6/5/20

Rain Garden Deficiencies

Andrew Timmis
31 Bristol Road

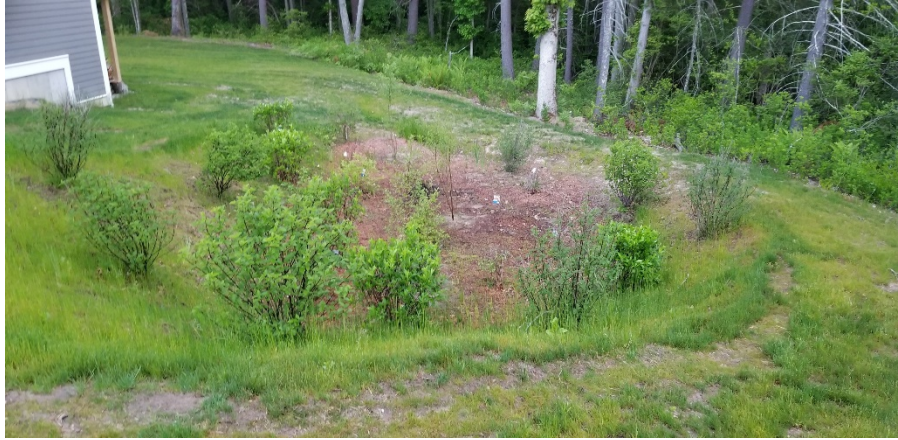
Grain Garden at 34 Bristol Road

This is what has been installed at 31 and 34 Bristol Road.

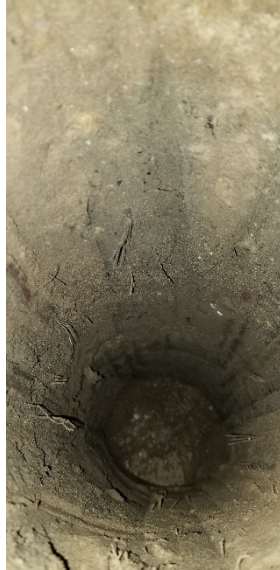
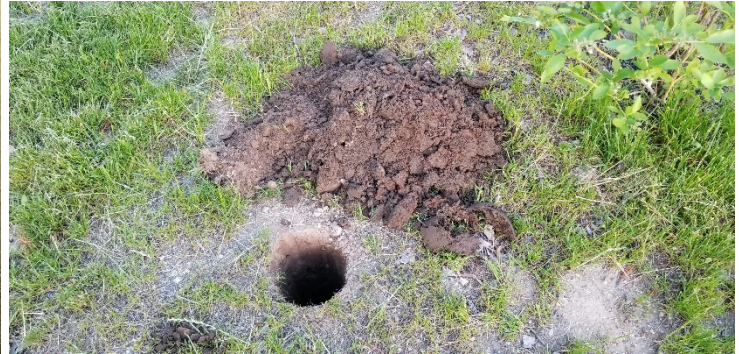
- There is no stone sub-base or filter media, or mulch. Could not determine if the removal of the sub-base occurred. (see photo below)
- The construction does not match the grade elevations on drawings creating a deep bowl. Maintenance is very difficult.

Pictures of the material in the garden, no mulch, no filter material or stone at the bottom

First: Allow for the redesign and reconstruct the rain gardens to match better the current conditions of the site eliminating the steep slopes and deep bowl design. This would require the regrading of the areas and start from scratch at a lower location of the yard.

Second: Allow for the reconstruct the gardens in there current locations to meet the required design but adjust the grades to reduce the slopes. Install actual topsoil to allow the regrowth of grass

Third: Allow for the elimination of the rain gardens altogether. Based on the final grades of the houses and driveways, they are obsolete. They are basically big holes with bushes and providing no value. No rain is being collected and going to the garden. This would allow the regrading of both lots to allow the use of the yard, maintain the yard. Quality topsoil would need to be installed to allow for grass to grow.

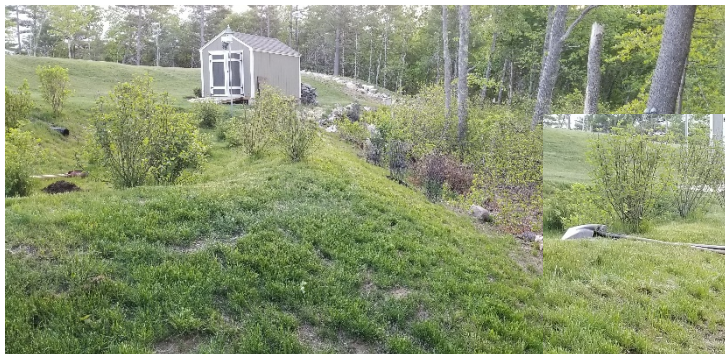
- The soil used to construct the basin/berms is from onsite material and has no organic content, and it is difficult to grow grass. It is also extremely high in fines (silts and clays), allowing for easy erosion and creating an impervious surface when dry.
- The plantings are not correct in species and are scattered not just in the bottom but around the sides.

Example of the steep slopes, lack of grass growth and elevation.

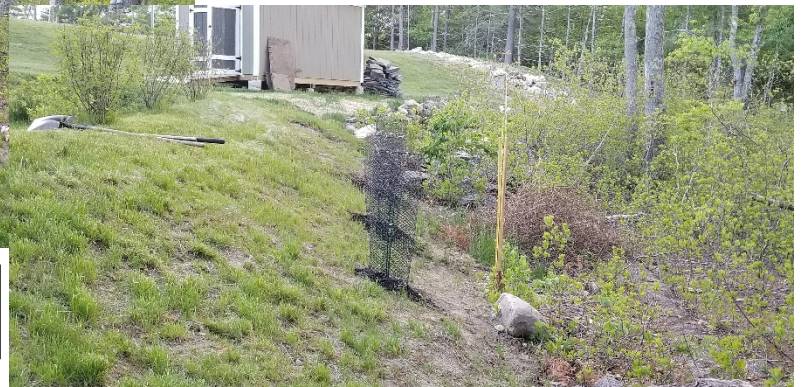
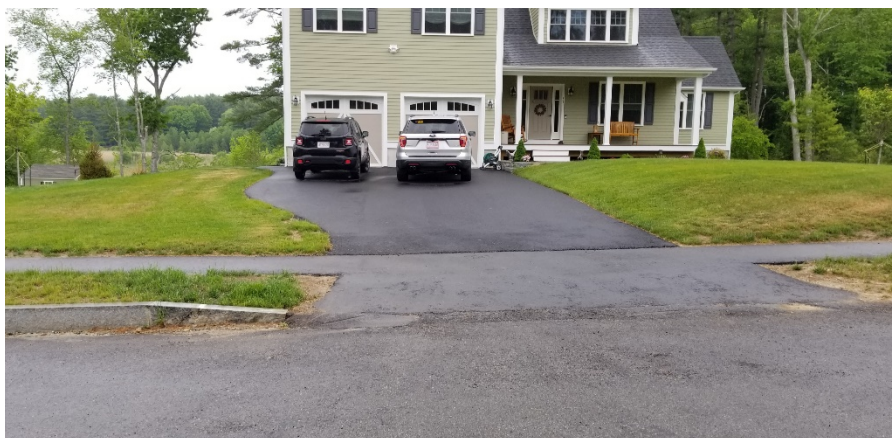
The drain along the driveway does not collect water and drain it into the rain garden. Due to the elevations of the house construction, the size of the driveway and the slope of the driveway, all the water drains to the street. The construction does not match the design on the drawings or referenced in the MDOT manual.

Driveway sloped to road, collection pipe is to the left of driveway

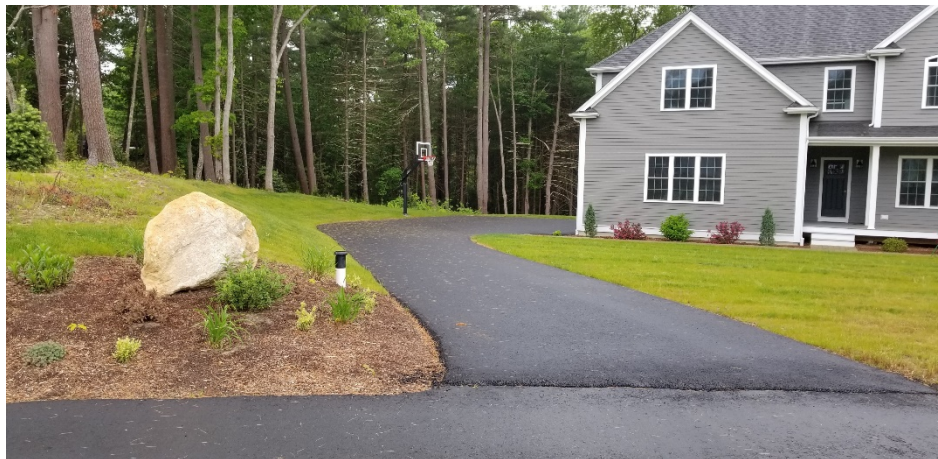
The drain along the driveway does not collect water and drain it into the rain garden. Due to the elevations of the house construction, the size of the driveway and the slope of the driveway, the majority of the water drains to the street. The construction does not match the design on the drawings or referenced in the MDOT manual.

Driveway note slope towards road, the drainage pipe is at the far end of the pavement

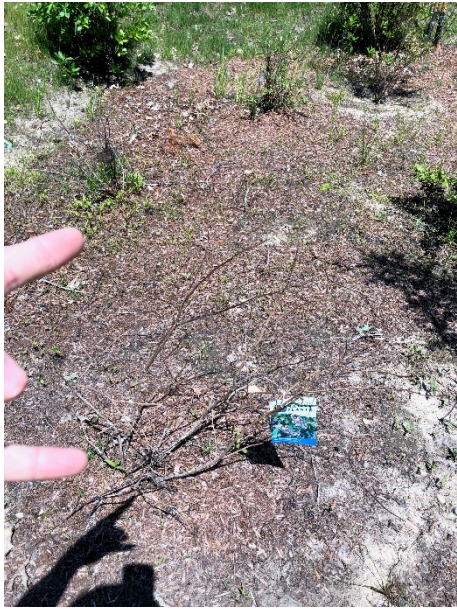
- The soil used to construct the basin/berms is from onsite material and has no organic content, and it is difficult to grow grass. It is also extremely high in fines (silts and clays), allowing for easy erosion and creating an impervious surface when dry.

- Plants root plugs exposed, improperly installed on the slope and throughout
- When construction was “completed,” the water did not drain and stagnated for many days. The “fix” was pumping out the water, and a small hole dug and filled pea stone and covered with dirt along with a thin layer of mulch.

Exposed roots, and bad soil that wont grow grass.

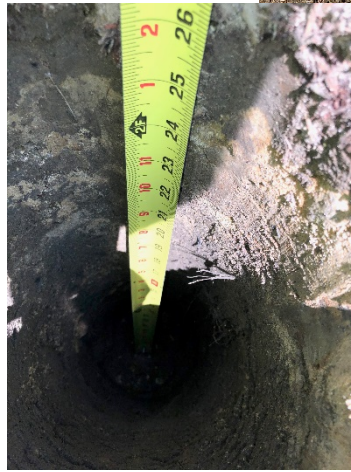
- There is no stone sub-base or filter media, or mulch. Could not determine if the removal of the sub-base occurred. (see photo below)
- The construction does not match the grade elevations on drawings creating a deep bowl. Maintenance is very difficult.

Soil from the bottom of garden, slight covering of mulch, no stone or filter material

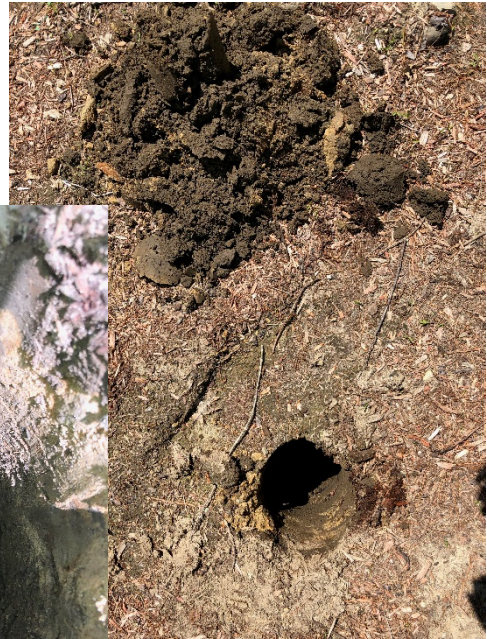
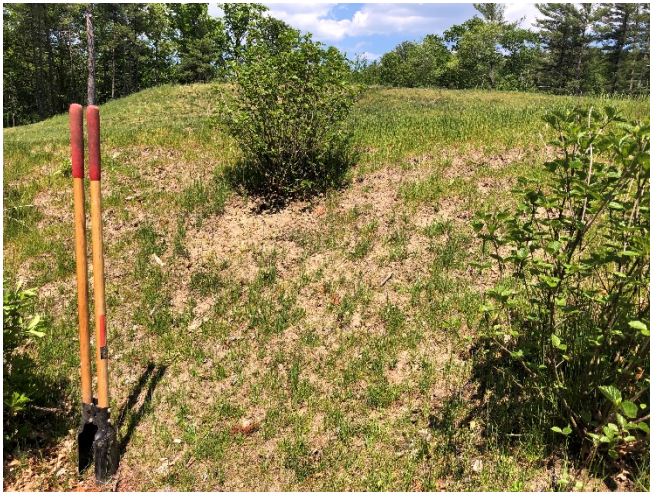
- The plantings are not correct in species and are scattered not just in the bottom but around the sides.
- The steep front slope washed out multiple times during construction

Steep slope and poor soil

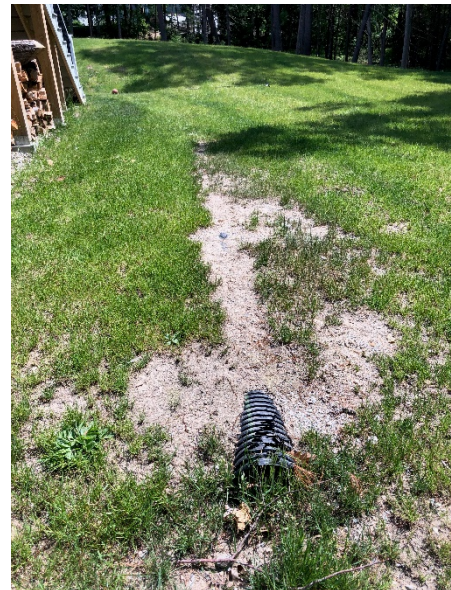
Drainage Pipe

- Drainpipe water flow from the driveway barely even trickles out any rainwater. Most of what fills the area come from direct rainfall and what drains from the lawn.

- The drain pipe elevation is too high, so insufficient dirt cover to grow grass.
- The size of the rain garden is too big for the relative size of the driveway.
