1. Purpose and scope of this memorandum

This memorandum summarizes a site survey performed on July 18, 2008 to evaluate the condition of ADA-mandated accessibility at the Police Station in Pembroke Massachusetts. After a description of the site and interior conditions of the building, recommended improvements are provided in Section 7, beginning on page 8.

The subject property is the Pembroke Police Station at 80 Center Street.

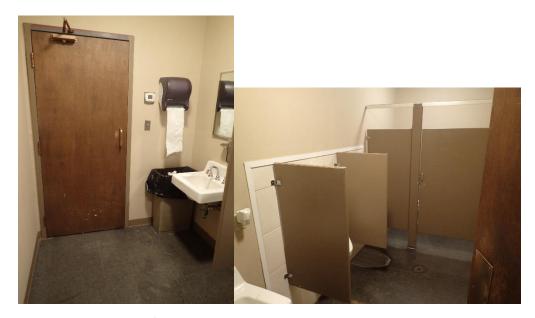
ii. First Floor Men's Room

This room is designated as accessible, and is provided with an automatic door operator. As noted above, the exterior signage is not ADA-compliant. The interior of the toilet room is non-compliant is several respects:

- The entrance door swing interferes with the required clear floor space at the lavatory
- Supply and waste piping beneath the lavatory is not covered or insulated.
- The urinals are mounted higher than the 17" ADA maximum.
- The is insufficient clearance at the door to the toilet stall.
