#### 1. Purpose and scope of this memorandum

This memorandum summarizes a site survey performed on July 18, 2008 to evaluate the condition of ADA-mandated accessibility at the Fire Station in Pembroke Massachusetts. After a description of the site and interior conditions of the building, recommended improvements are provided in Section 7, beginning on page 8.

The subject property is the Pembroke Fire Station at 172 Center Street, at the corner of Elliot Avenue.

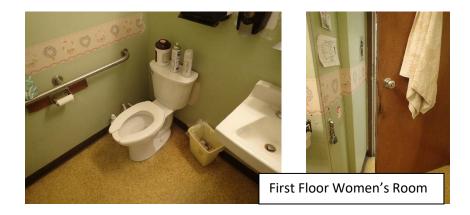
This room is also not designated as accessible. The exterior signage is not ADA-compliant. The interior of the toilet room is non-compliant in several respects:

- Insufficient clearance between the toilet and lavatory (60" clear space at the back wall is required for the toilet)
- · Rear wall grab bar is missing.
- Insufficient space between toilet and opposite wall (42" required, 31" provided)
- The bottom edge of the mirror is mounted above the maximum 40" limit.
- Supply and waste piping beneath the lavatory is not covered or insulated.
- Lavatory lacks lever-handle faucets.
- Door hardware and clearance is non-compliant.

We note that the room is probably too small to be made fully accessible.

Provide at least one ADA-compliant toilet room for public and administrative staff. Subject to regulatory approval, this may be allowed as a unisex facility. The larger locker/shower/toilet room may be considered for firefighters' use only.
